The effect of ozone on surface hardness of restorative materials.

To investigate the effect of ozone treatment on the surface hardness of a range of commonly used restorative materials.

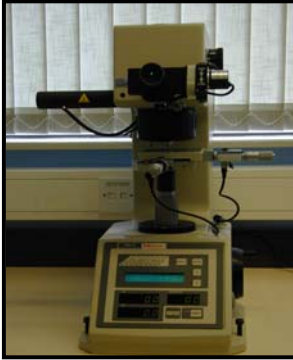
Photograph 2:

The materials were then subjected to Micro Vickers Hardness Testing (Mitutoyo), (photograph 2) applying a load of 1kg for 10 seconds and the results recorded.
